Minimizing collision/grounding claims - from BRM aspect -

Tetsuro Nakamura, Yoshida & Partners

Loss Prevention Workshop at IUMI 2013
on September 18, 2013 in London

GROUNDING AFTER COLLISION IN INLAND SEA OFF HIROSHIMA

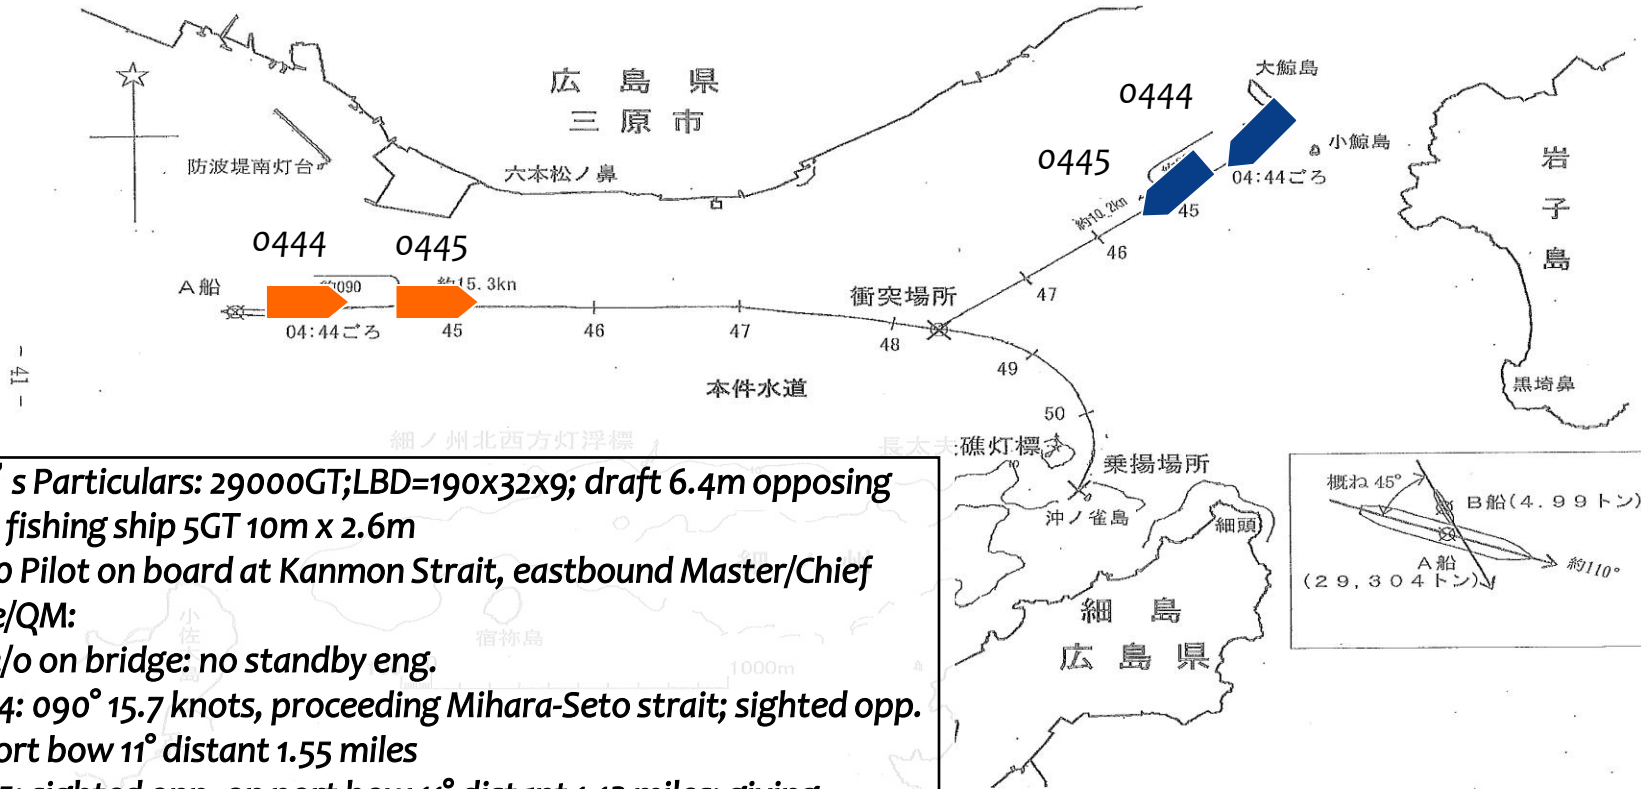
Mihara Seto – Collision and Grounding

grounding after collision

Ship's Particulars: 29000GT;LBD=190x32x9; draft 6.4m opposing ship: fishing ship 5GT 10m x 2.6m

- 2030 Pilot on board at Kanmon Strait, eastbound Master/Chief mate/QM:
- no 2/o on bridge: no standby eng.
- 0444: 090° 15.7 knots, proceeding Mihara-Seto strait; sighted opp. on port bow 11° distant 1.55 miles
- 0445: sighted opp. on port bow 11° distant 1.13 miles; giving lighting and sound signals to warn opp.

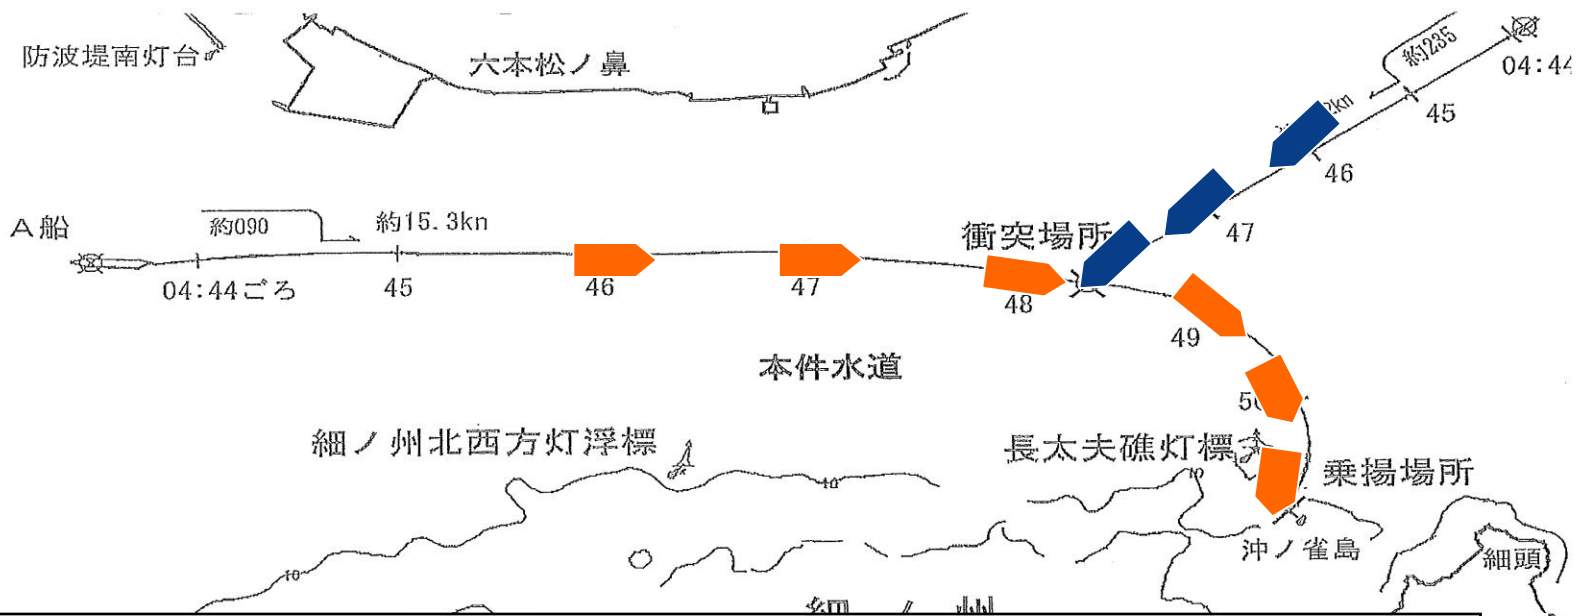
- 0446: starboard 10° toward right end of strait; opp. echo on port bow 12°, 1,390m
- 0447: opp. echo on port bow 17°, 880m. no sight of opp. nav. light; blast sound sig. keeping starboard 10° helm
- 0448: opp. on port bow 450m; hard starboard; collision on her port quarter with opp. stem.
- 0449: stop eng. hard port, but no stop of starboard turn.
- 0450: dead slow ahead
- 0451: slow ahead. finding close distance to Oki-no-suzume Island, stop eng. and full astern
- 0452: grounding

Error Chains

- **(a. passage plan)**
remark on chart planned tracks. dangerous points
- number of crew on bridge at each stage.
- **(b. briefing passage plan with crew and pilot)**
- confirming each 's role; enough number of crew on bridge?
- **(c. monitoring progress)**
insufficient lookout for fishing ships and shallow places; fix position after collision
- **(d. teamwork)**
insufficient report and communication
(position, speed, fishing ships); where each crew is standing.

- On the ship
- (not to mention) keeping basic knowledge and learning how to use navigational equipment
- Briefing before passing narrow navigable waters
- Notice to crew re pilot on board; crew's BRM recognition and collaboration (reporting, close information exchange; consulting)
- Improving crew's life on ship (close communication in daily life)

- As the owner/manager
- More visits or phone calls to ships to grasp personnel relationships on ships and to make effective instruction
- Attend on voyage; grasp the atmosphere of bridge/engine room; watch supervision at the site
- Attend crew's BRM training outside; know the crew's characters and give advise.
- BRM should be one of factors for review of crew's performance.
- Develop database for passage plans
