MARITIME SAFETY COMMITTEE
102nd session
Agenda item 21

MSC 102/INF.3
7 February 2020
ENGLISH ONLY
Pre-session public release:

Analysis of current safety regulations concerning fire-fighting on board containerhips

**ANALYSIS OF CURRENT SAFETY REGULATIONS
CONCERNING FIREFIGHTING ONBOARD OF CONTAINERSHIPS**

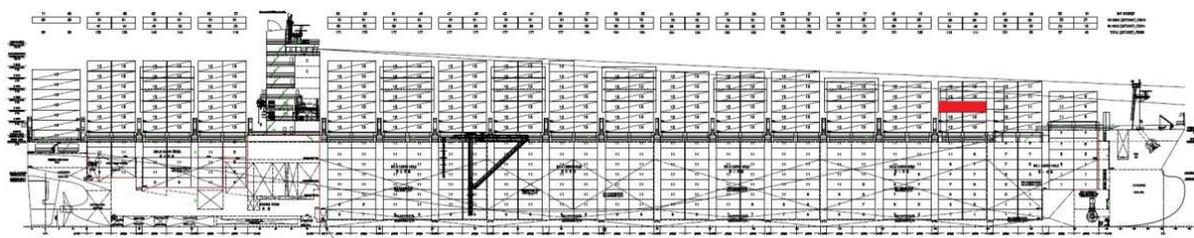
Figure 1: Side view of the example vessel with the burning container on deck [5]

In this scenario a container on the forecastle in bay 10, row 02, tier 03 had caught fire. The fire was detected by the officer of the watch on the bridge due to heavy smoke emissions. After informing the vessel's Master the general alarm was activated and the crew was mustered. At this point of time about 10 minutes had passed since the detection of the fire.

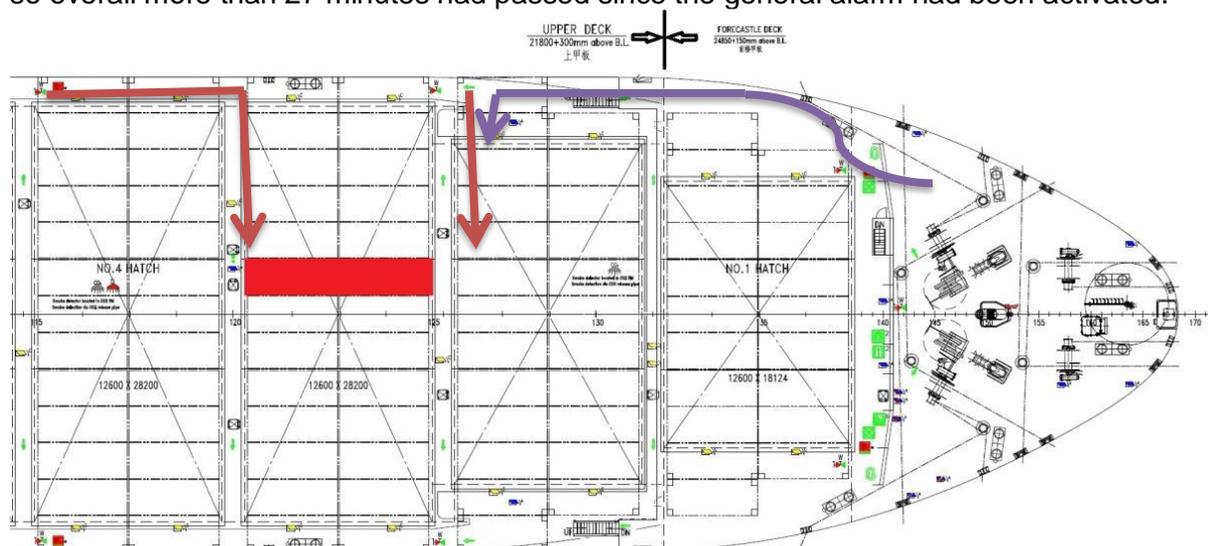
Figure 3: Top view of the upper deck of the example vessel with the burning container on deck [5]
Hoses used for firefighting are marked red, respectively purple

Forward and aft of bay 10 hoses with a length of 25 m were connected to the fire hydrants (marked red in figure 3). A further fire hose was taken from another fire hose box because at the operational area there was no fire hose box installed (marked purple in figure 3). Another 5 minutes had passed until the fire line was charged and the cooling of the containers began; so overall more than 27 minutes had passed since the general alarm had been activated.

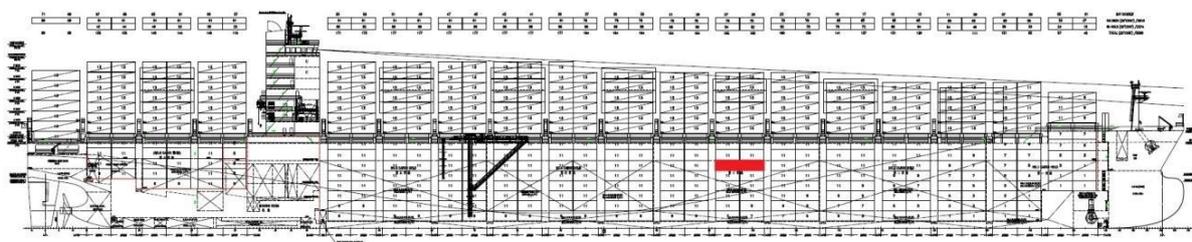
Figure 4: Side view of the sample vessel with the burning container in the cargo hold [5]

In this scenario a container on the forecastle in bay 26, row 01, tier 06 in cargo hold no. 3 had caught fire. The fire was detected by the combined fume extraction and CO₂ extinguishing system with an alarm on the bridge. In order to exclude a false alarm, the watchman equipped with a handheld VHF radio set was sent for control to cargo hold no. 3. For the distance of about 150 m from the bridge to cargo hold no. 3 the watchman needed 2 minutes. Via VHF he reported to the bridge smoke escaping from the ventilation flaps of cargo hold no. 3. After informing the vessel's Master of the situation the general alarm was activated and the crew was mustered. Mustering and informing the crew took approx. 10 minutes.

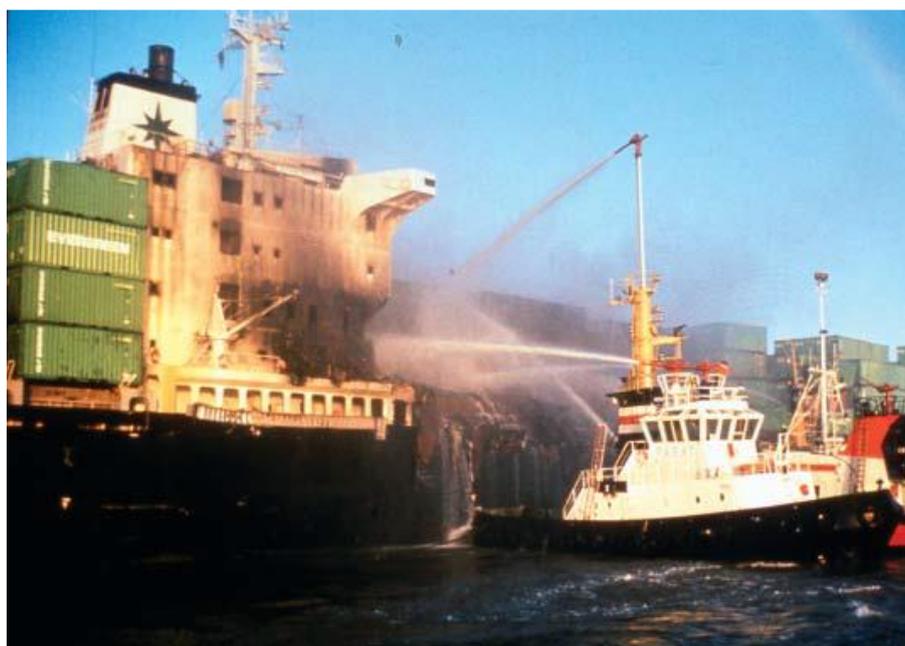
Figure 6: "EVER LEVEL" burning after the collision with "ITAPAGÉ" [15]

Due to the attrition of both vessels high thermal energy was released with the consequence that containers loaded with fireworks immediately caught fire. The fire flashed over to the accommodation, burning containers fell overboard, and "EVER LEVEL" developed a list.

Three firefighting boats and ten tug boats were involved in the firefighting. On 1 December 1983 the fire was under control and "EVER LEVEL" could be transferred to the Port of Brunsbüttel where the local fire brigade and the plant fire brigade of Bayer AG finally extinguished the fire.

On 3 December 1983 "EVER LEVEL" moved under own power and with tug assistance to Hamburg to discharge the containers. Afterwards she was repaired at Blohm & Voss Shipyard in Hamburg.

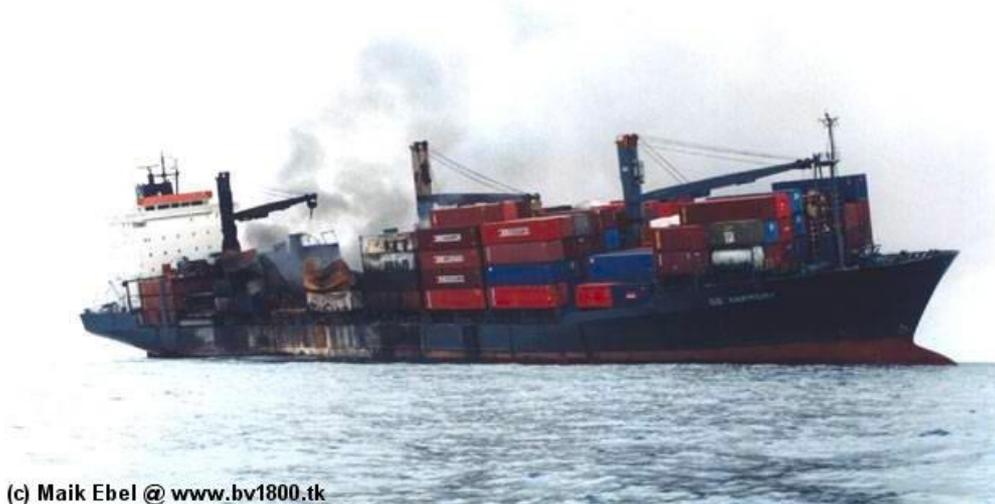
**Figure 7: "DG HARMONY" burning after the explosion of calcium hypochlorite
[Source: Maik Ebel, www.bv1800.tk]**

The "DG HARMONY" continued to burn for three weeks. Most of its cargo was destroyed or damaged. The vessel itself was declared a constructive total loss and eventually scrapped."

It was found that the fire had started at bay 26, the forward part of hold no. 3, where ten containers of calcium hypochlorite were stowed. One 22-ton hatch cover had been blown off by the force of the explosion.
