CASE STUDIES

**AUSTRALIAN TROPICAL CYCLONES
YASI and OSWALD**

Des Ward

AUSTRALIAN MARINE CONSULTANTS PTY.LTD
IUMI Conference - Hong Kong - 23 September 2014

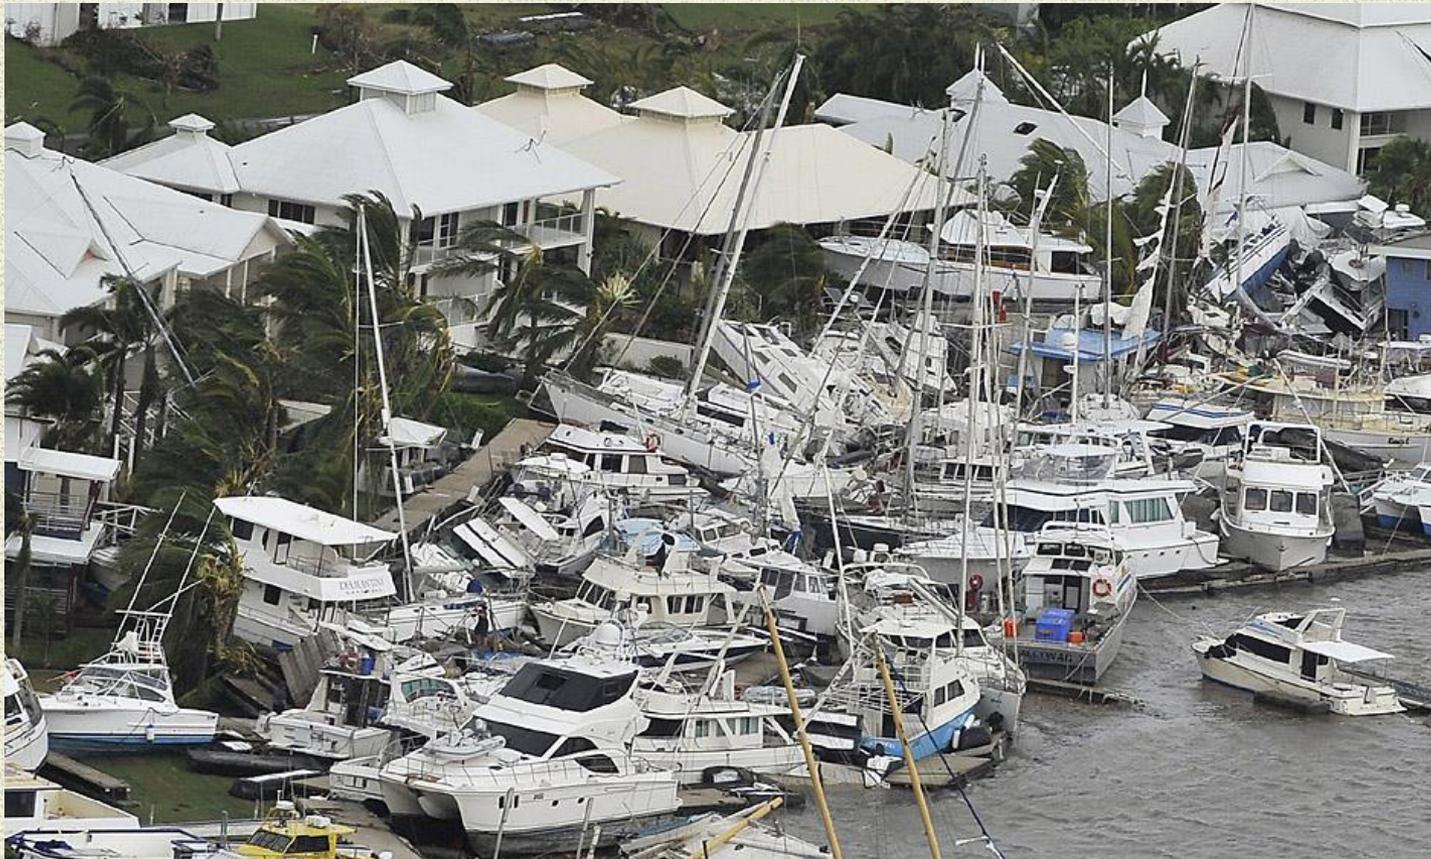
This is the iconic image of the marina destruction at Port Hinchinbrook later on the first morning.

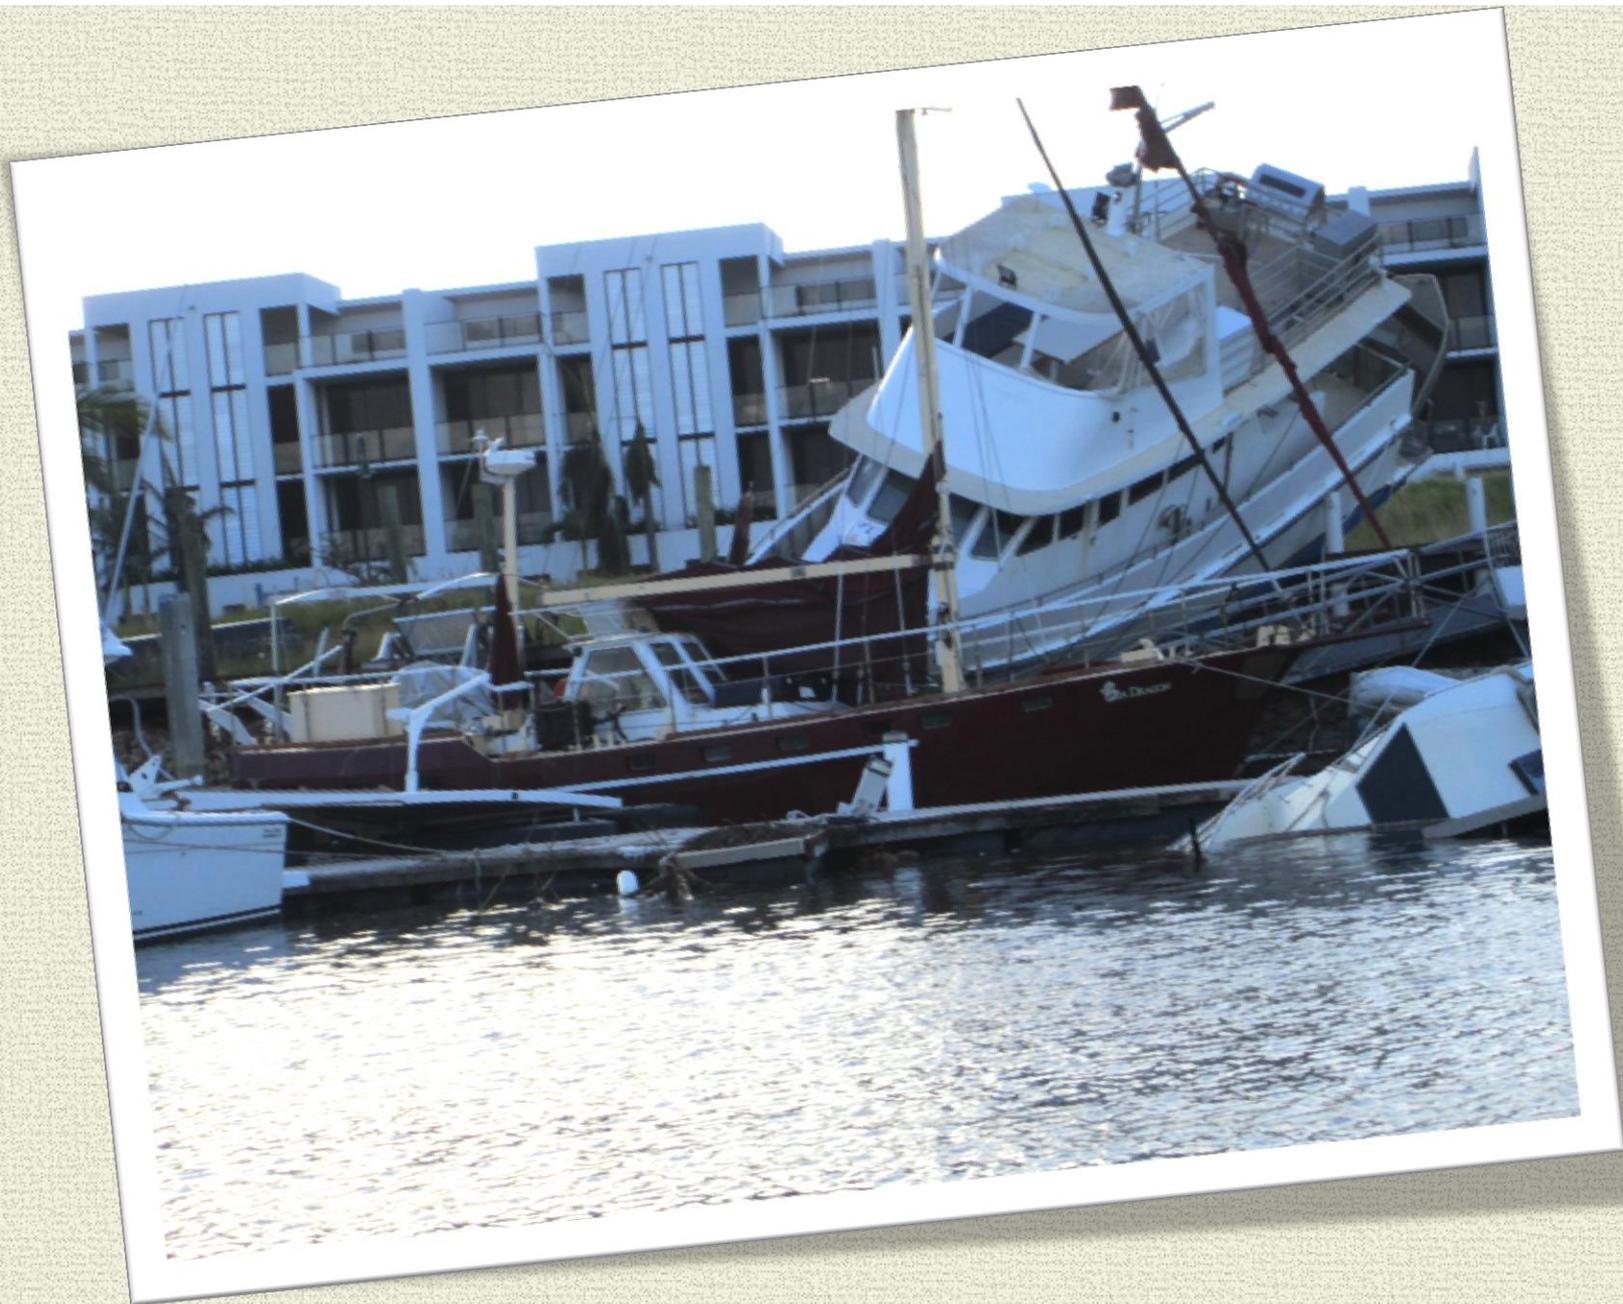
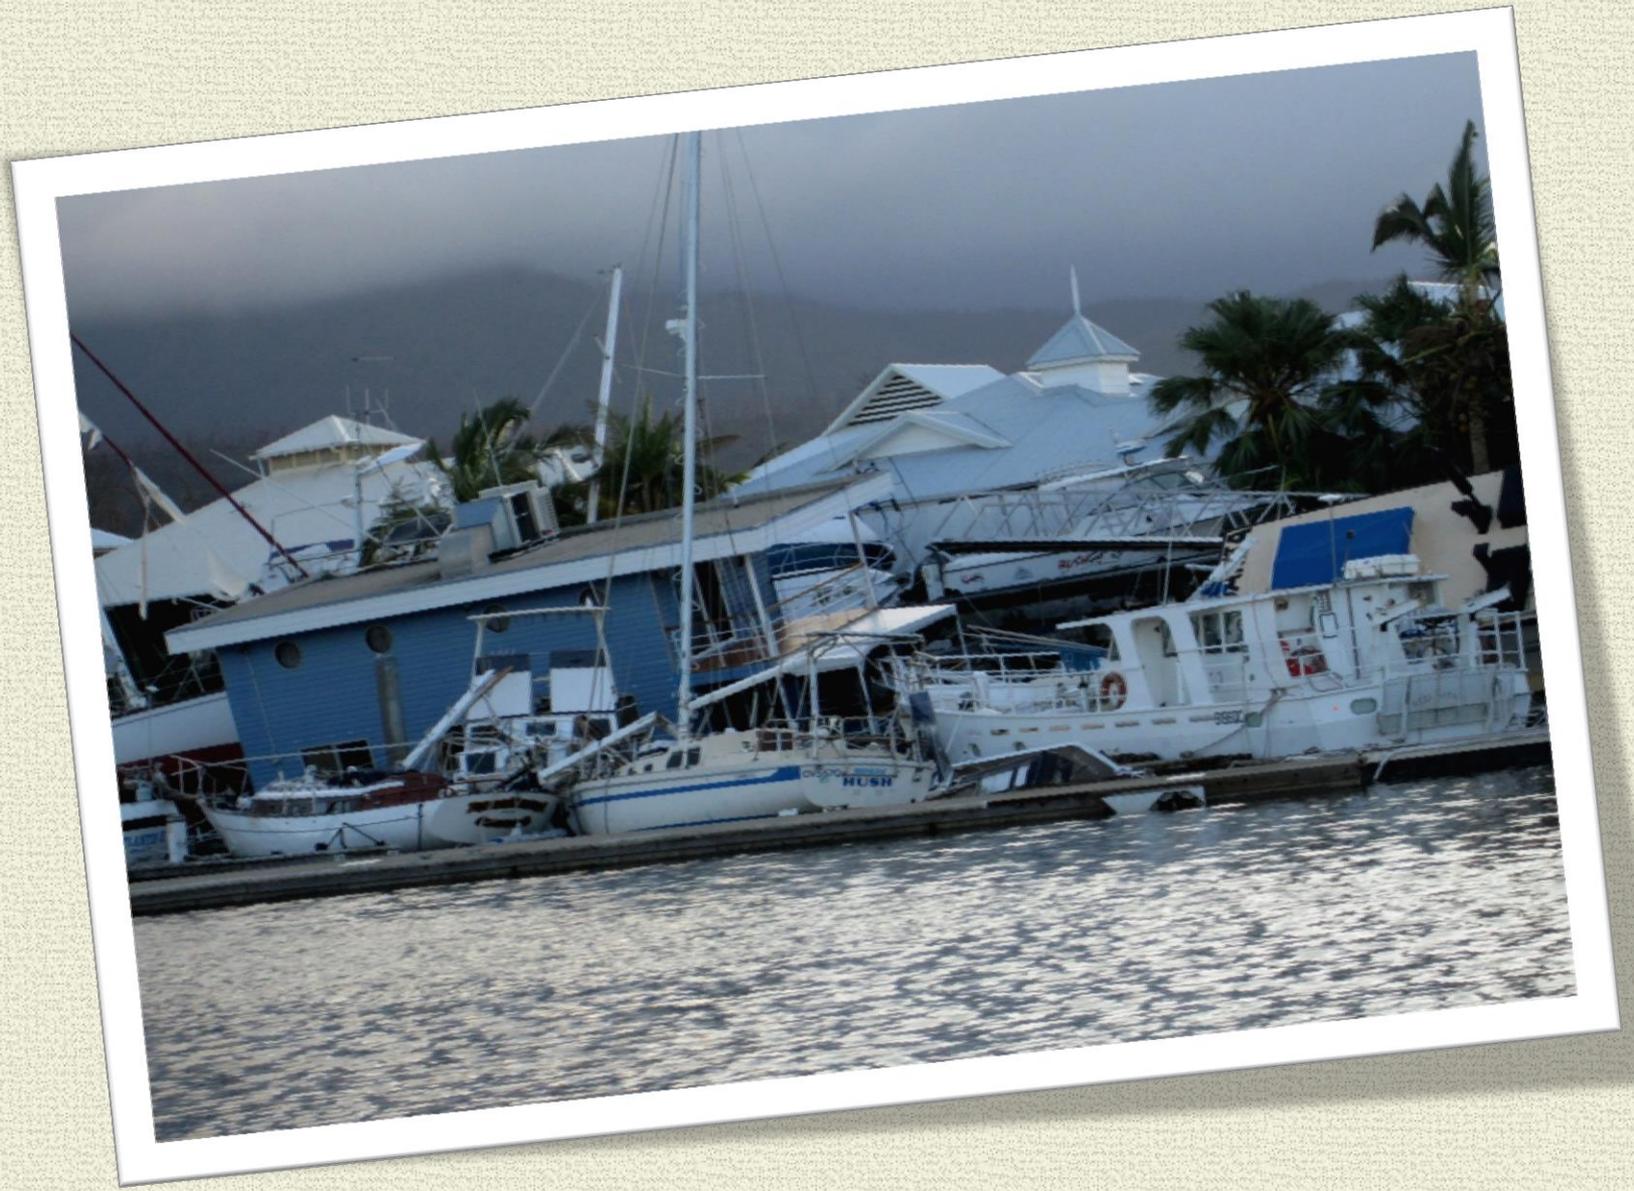
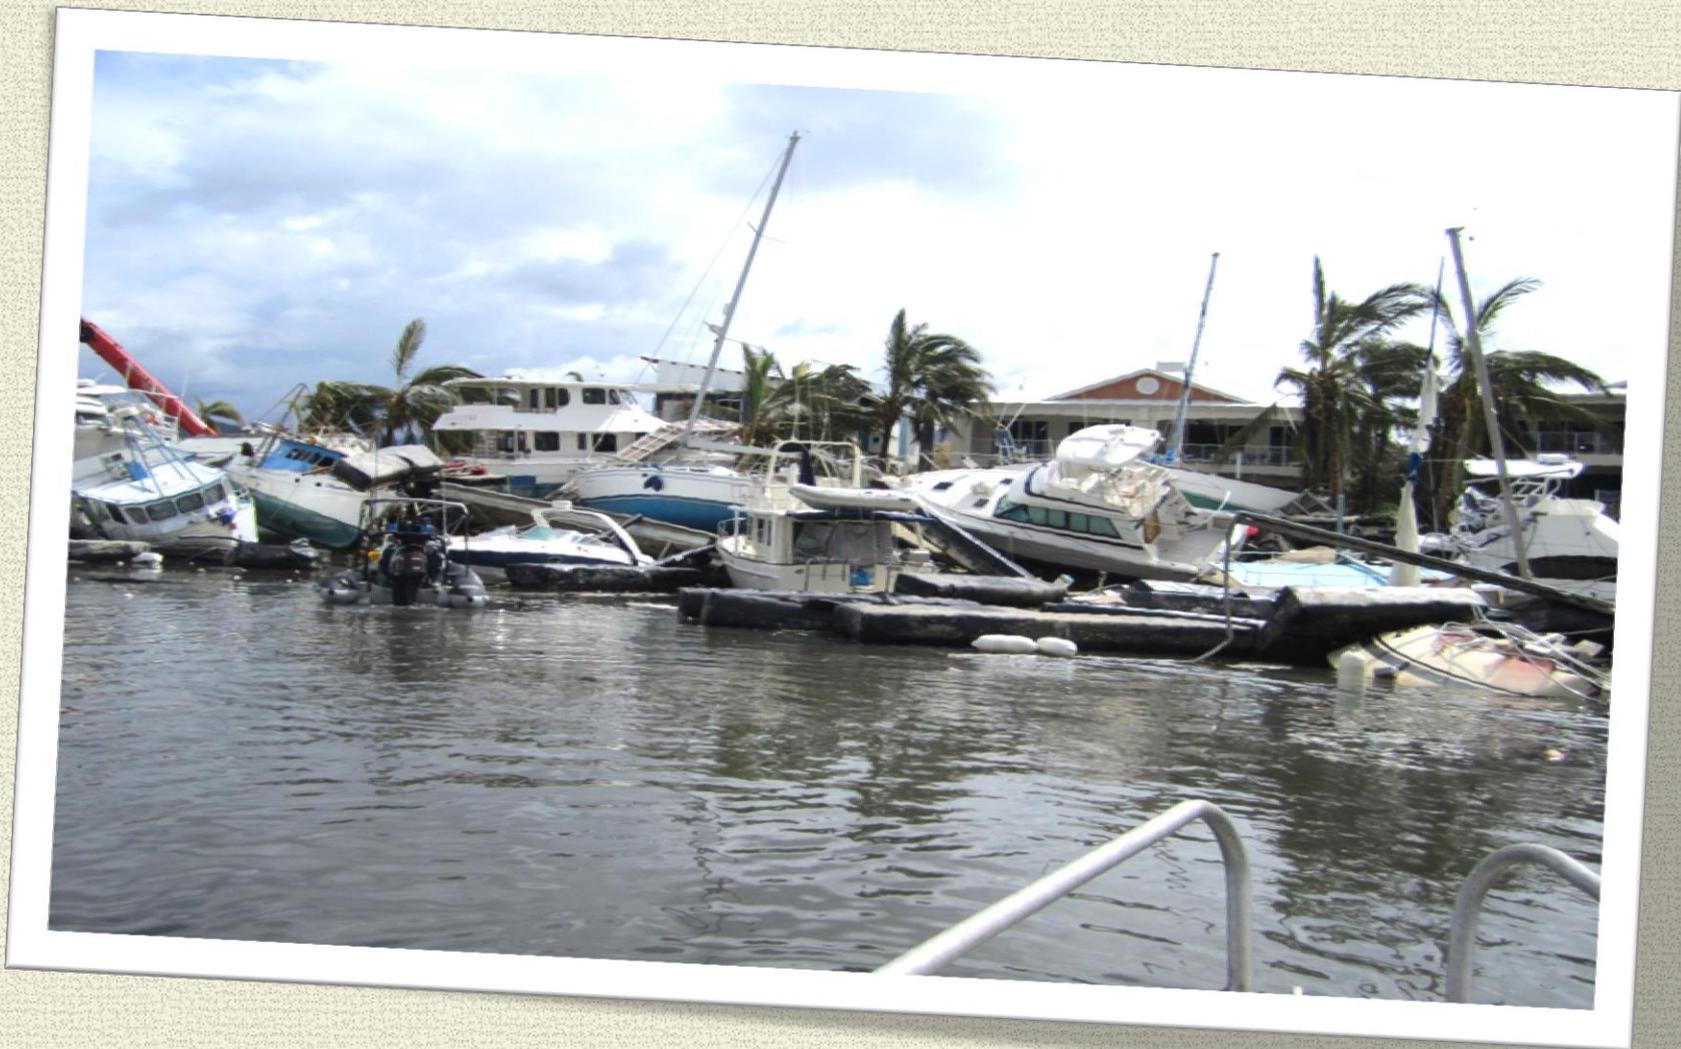
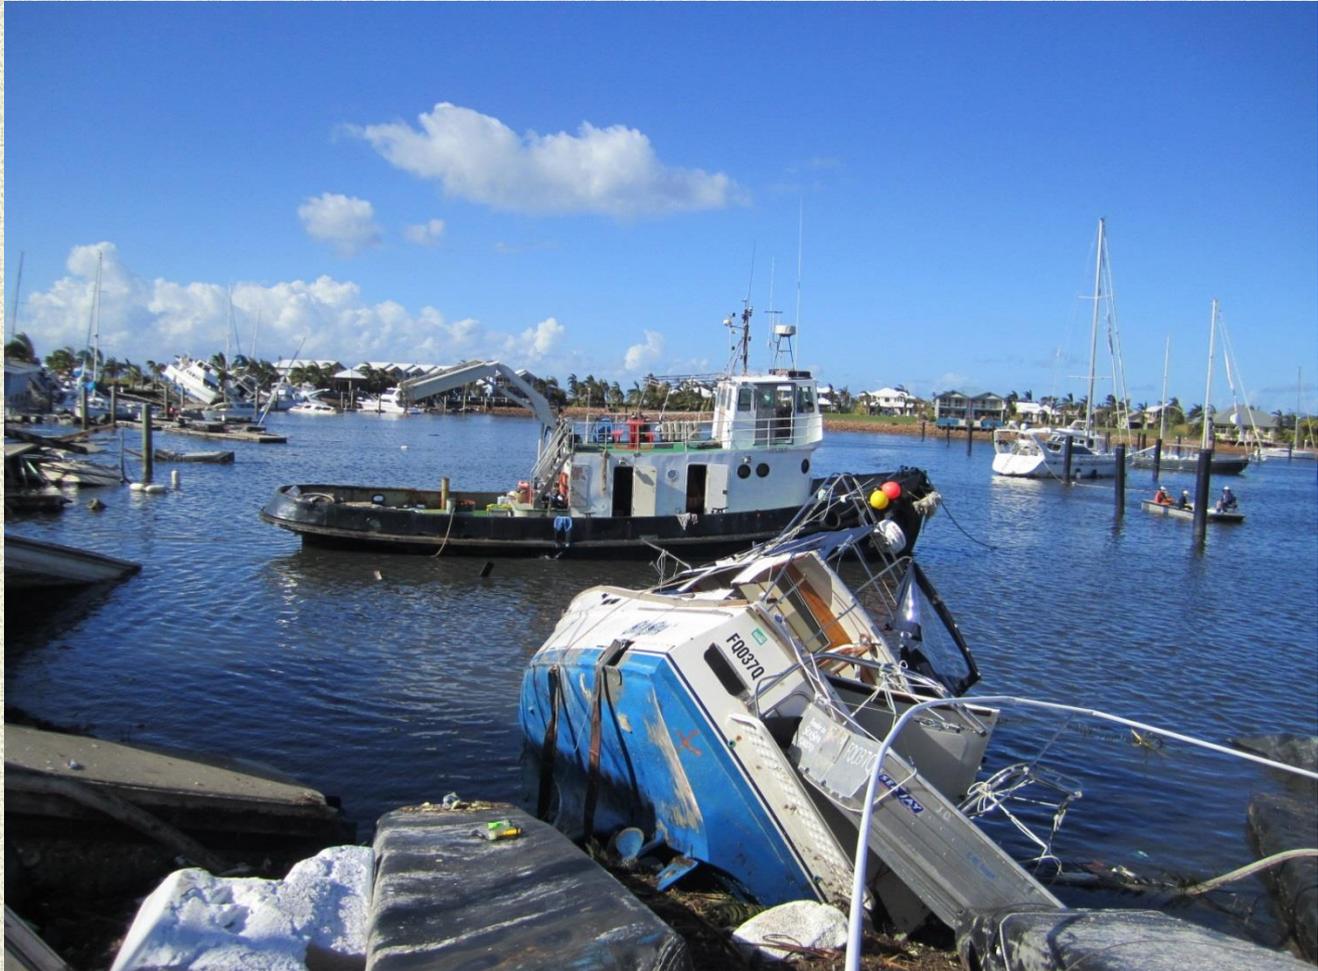
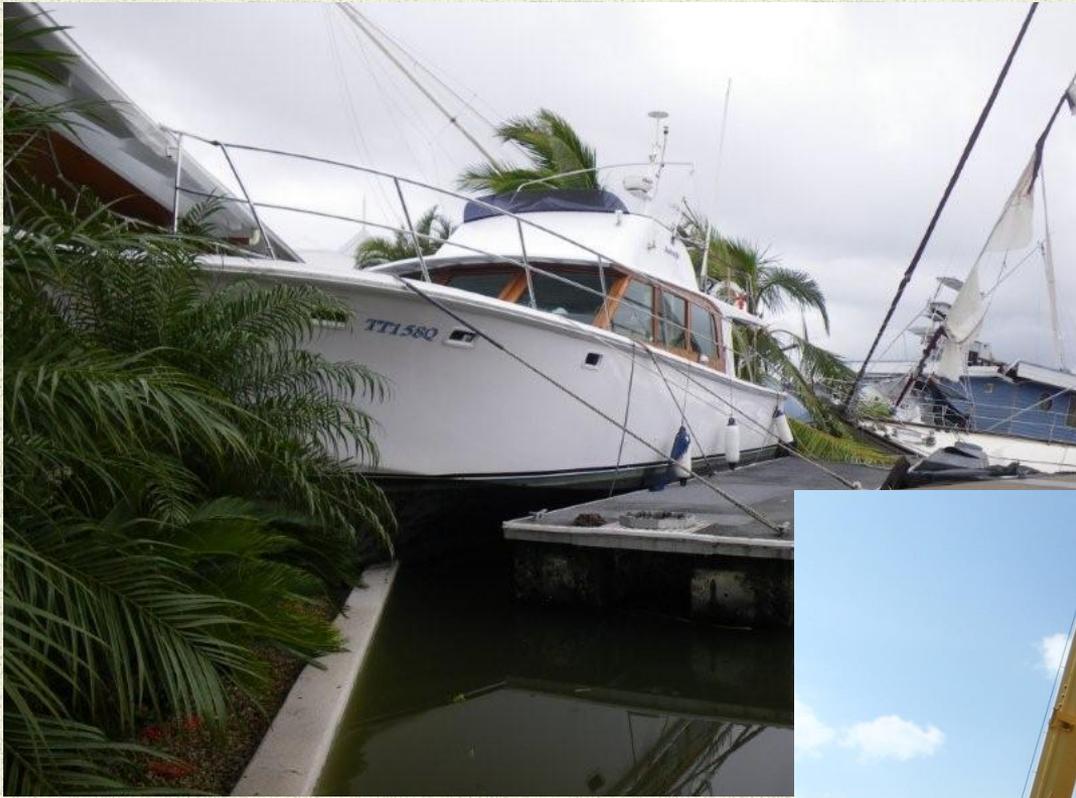
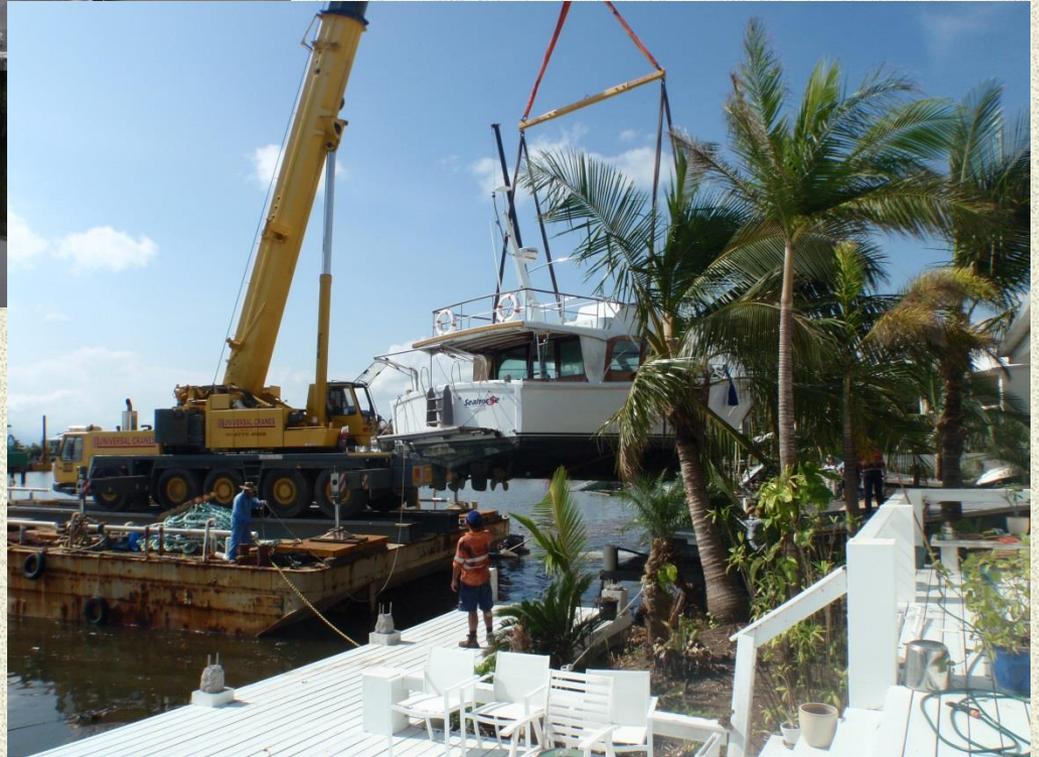
Many vessels on top of each other in the gardens of luxury villas facing the water.

- We got in to the site on day 1 with some difficulty- nearly 3 days before any other surveyors arrived – by then we had the job well under way.
- Emergency services had control and were causing more damage.
- Access had to be negotiated.

“Our first impression of the jumble of yachts was of a children’s game of ‘pick-up-sticks’ where each child picks a stick out of the pile in the hope that the whole lot does not come tumbling down. Fortunately, our approach was much more ordered. We started on the outside and worked our way in.”

“This approach allowed our team to identify each relevant vessel, their owner and insurer in a logical manner. We organised the vessel’s removal so that the salvage team could gain access to identify the damage.”

“Each vessel had to be individually assessed to see if it could be repaired or was a total loss. One of our key challenges was to make it as painless as possible for their owners.”

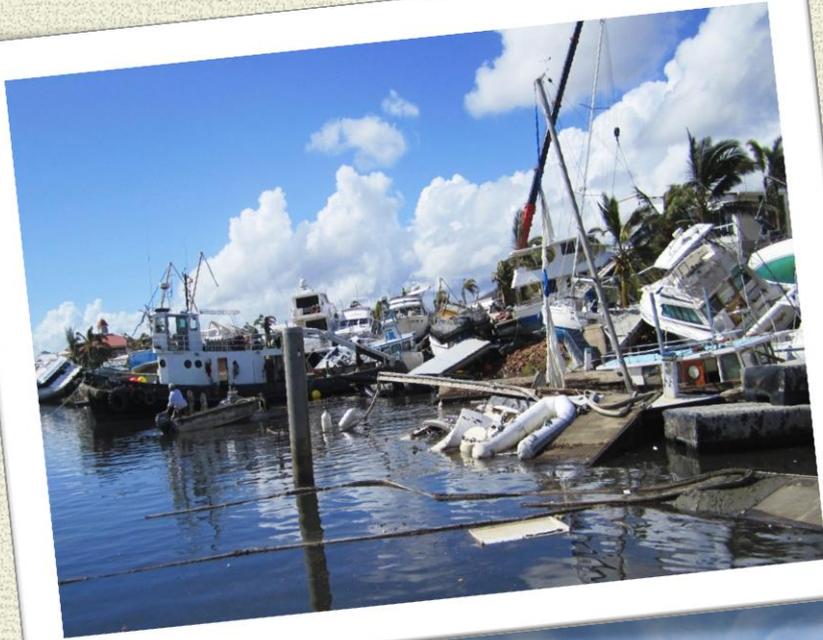
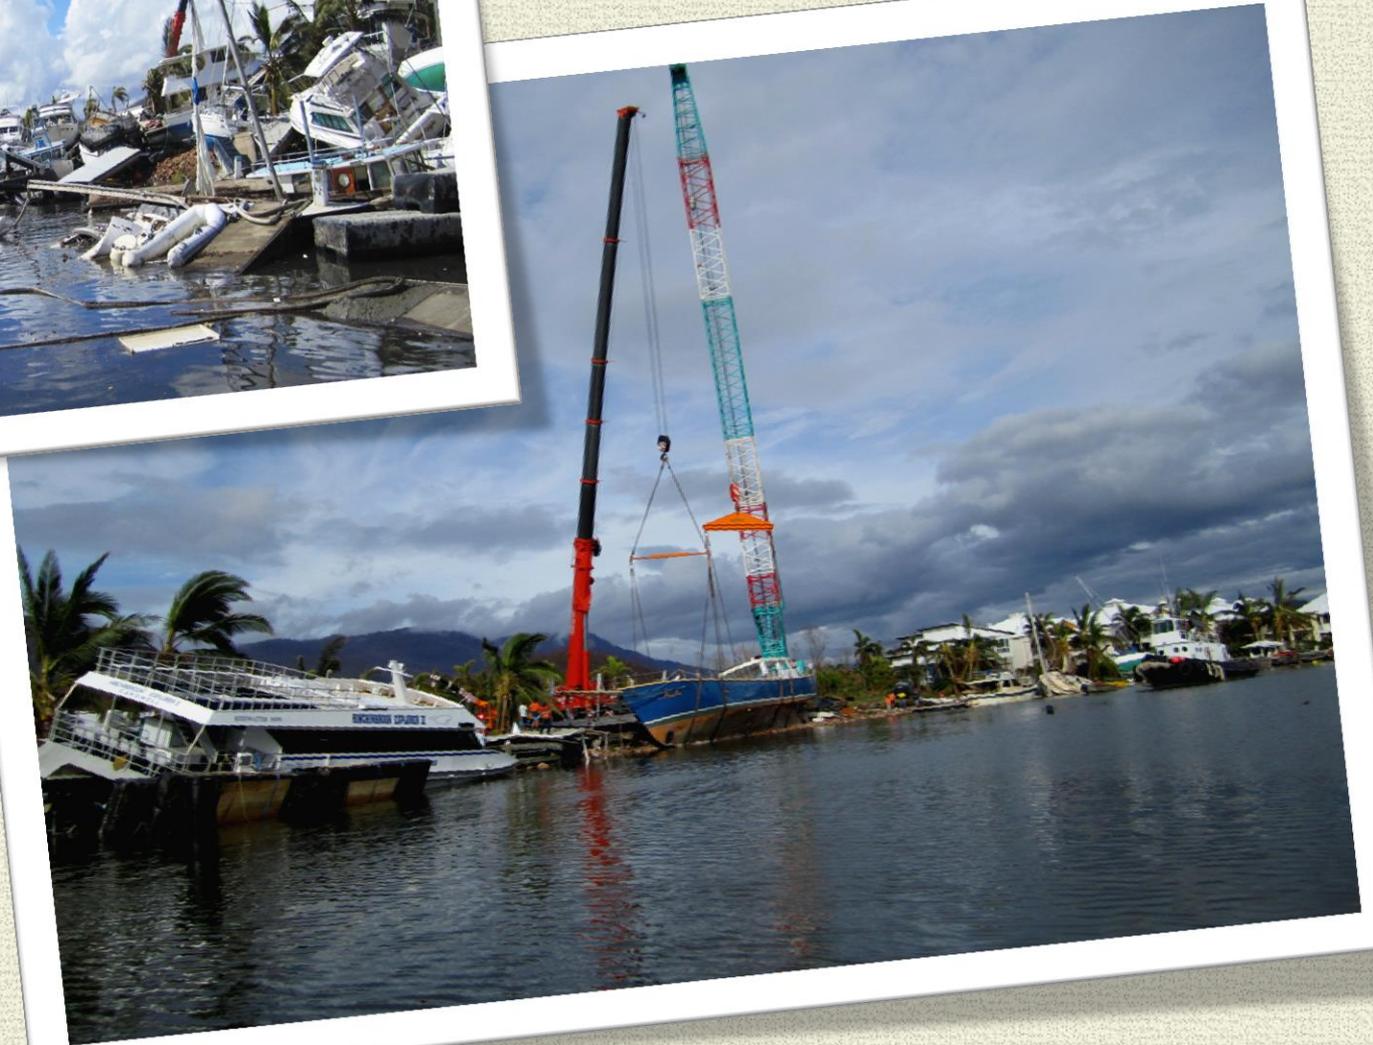
Operation took many weeks – cranes, divers, demolition crews etc.

Careful apportionment of costs.

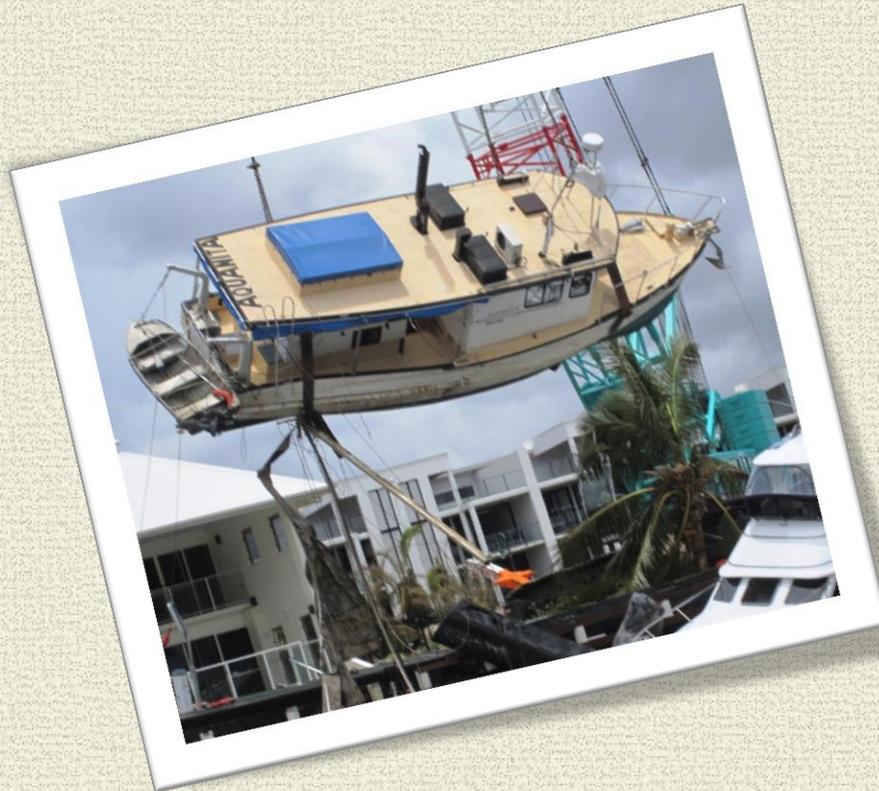
The last boat.....

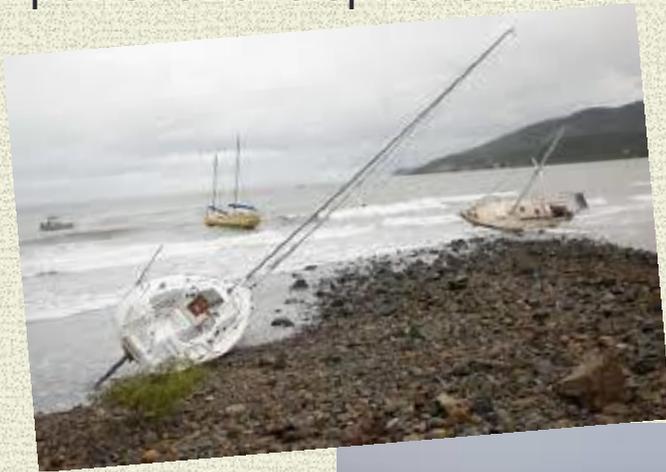
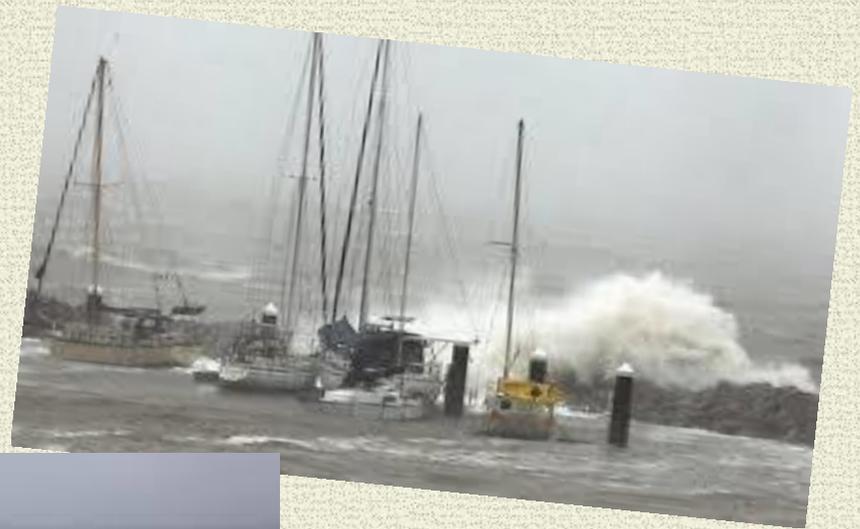
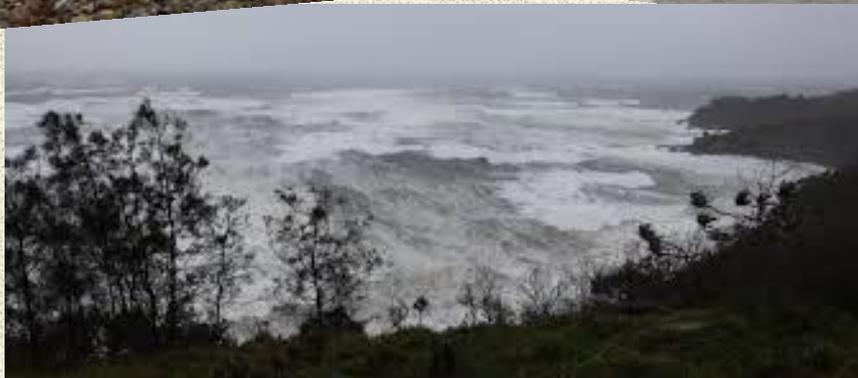
Although no longer a cyclone the system caused heavy rain and swells which led to widespread damage to vessels and infrastructure over a very long distance of coastline.

There was widespread flooding and 6 lives were lost. In some places rainfall reached almost 1.5 metres over a 4 day period. Rivers reached record heights and thousands lost power and telephone lines.

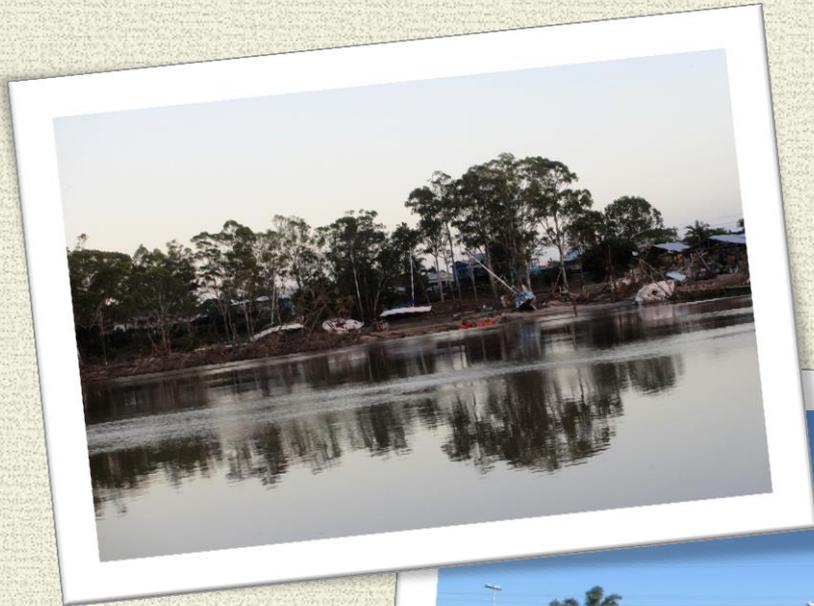
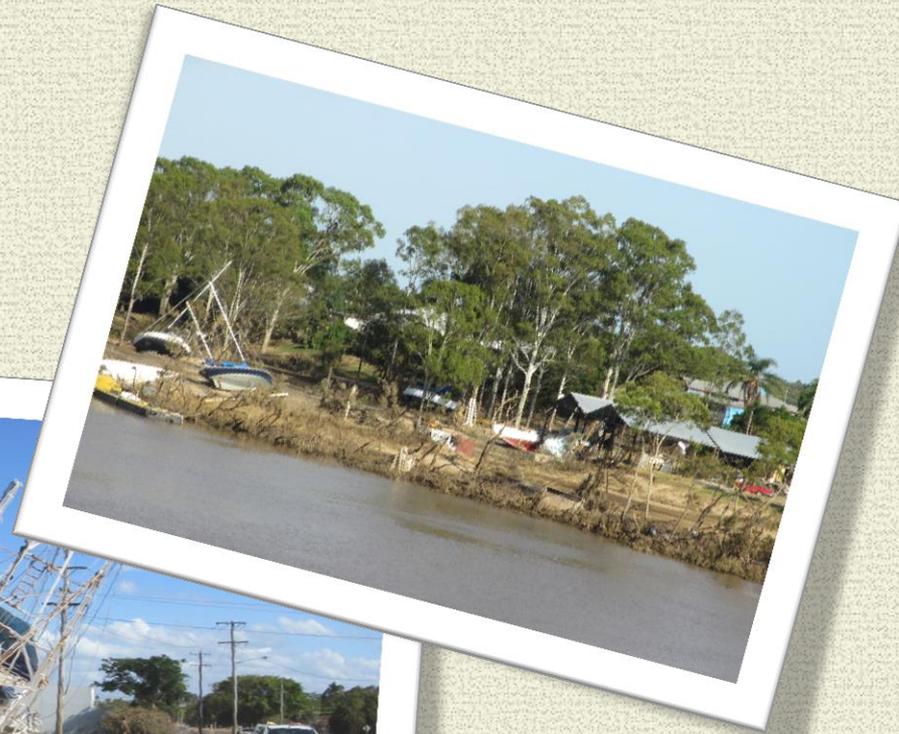
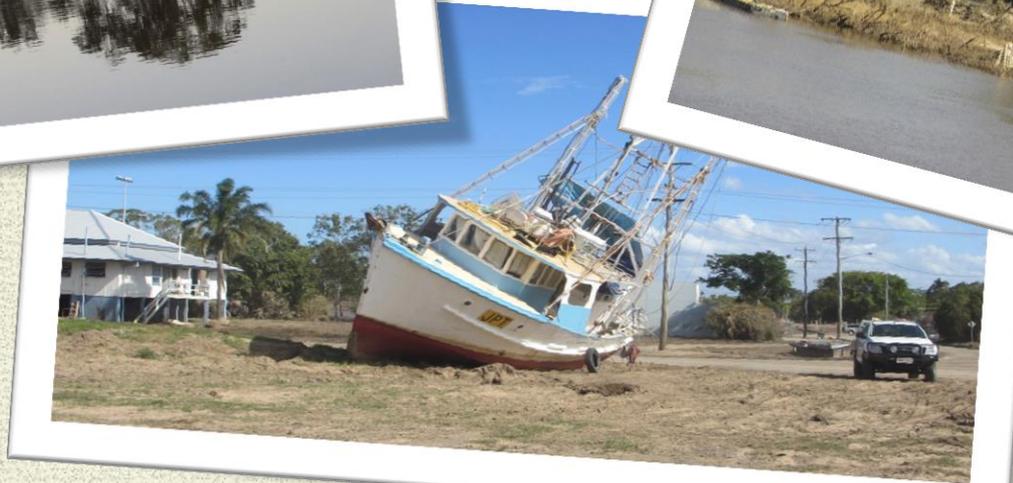
- Burnett River, Bundaberg hit record level of 9.53m. Some vessels up to about 30m were washed out to sea never to be seen again....
- Losses estimated at more than \$3.0bn – insured losses \$1.0bn.
