Minimizing collision/grounding claims - from BRM aspect -

Tetsuro Nakamura, Yoshida & Partners

Loss Prevention Workshop at IUMI 2013
on September 18, 2013 in London

GROUNDING AFTER COLLISION IN INLAND SEA OFF HIROSHIMA

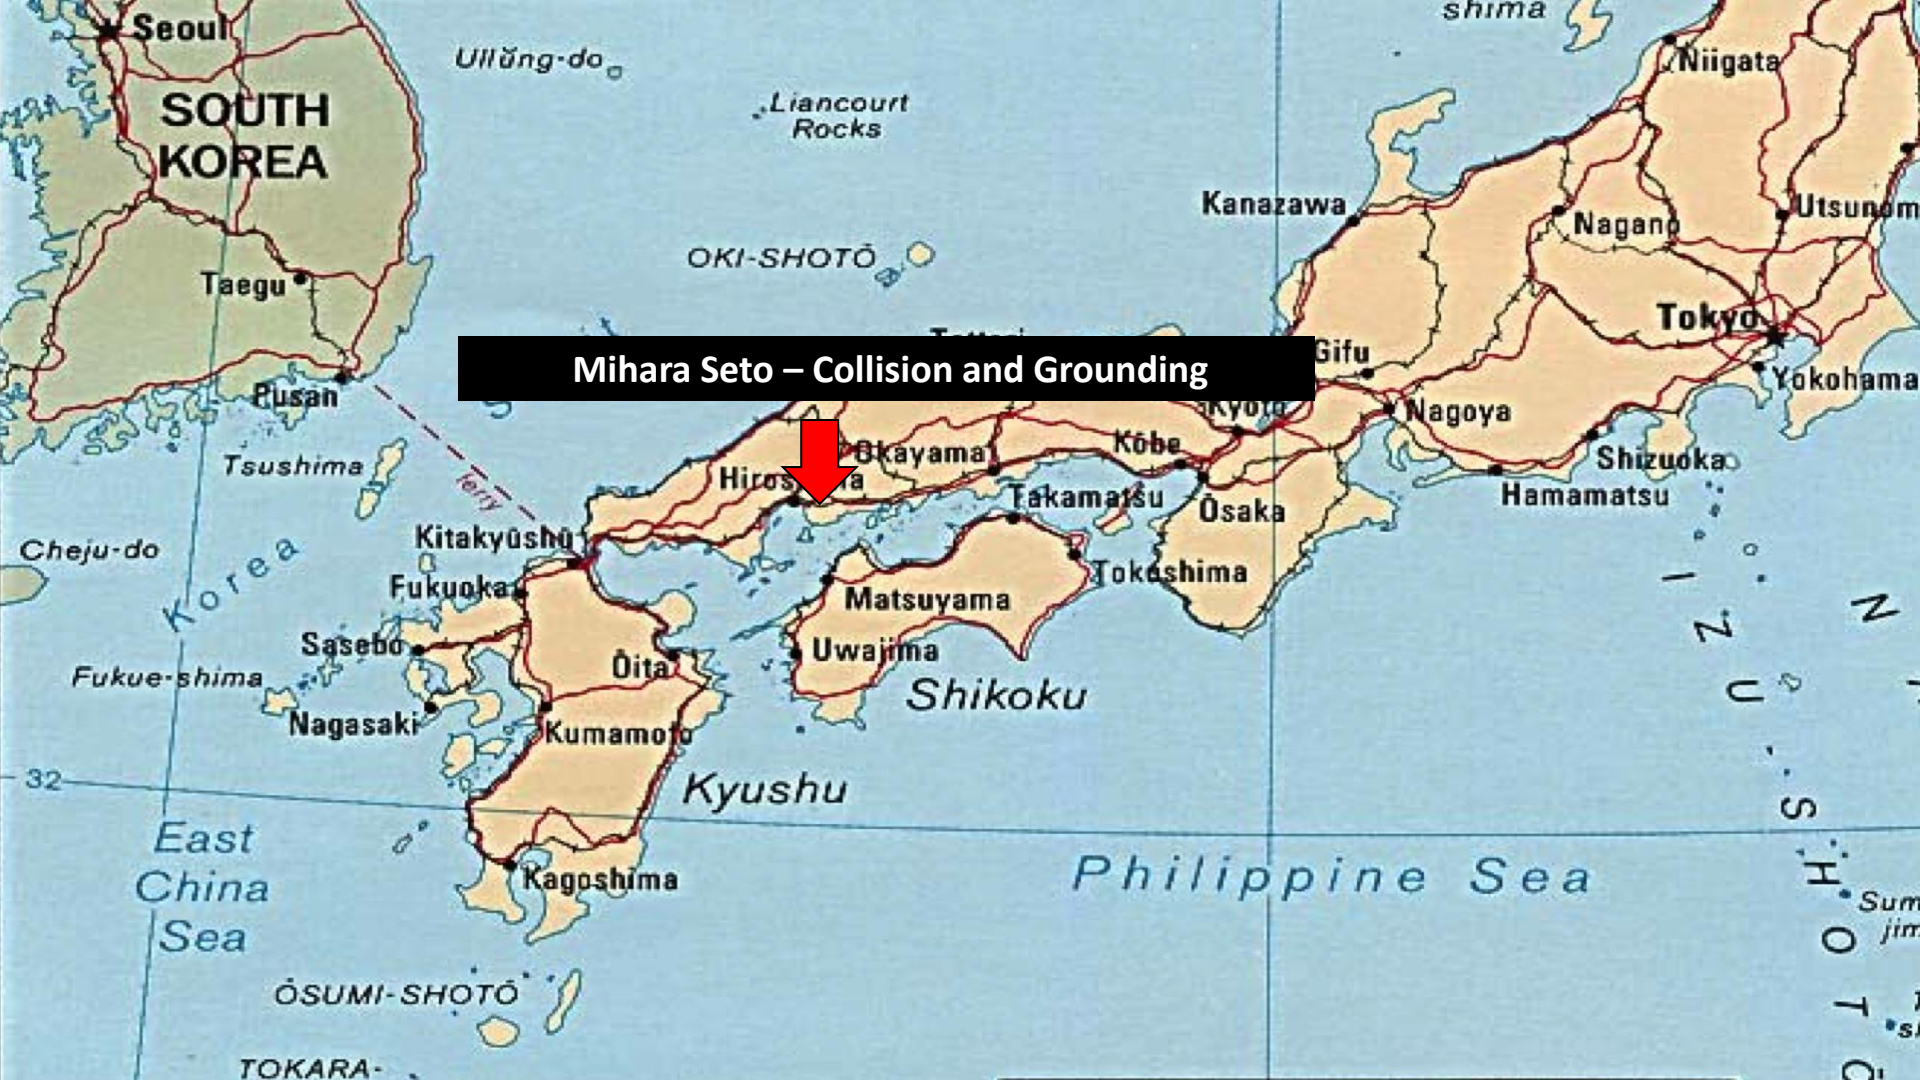
Mihara Seto – Collision and Grounding

grounding after collision

Ship's Particulars: 29000GT;LBD=190x32x9; draft 6.4m opposing ship: fishing ship 5GT 10m x 2.6m

- 2030 Pilot on board at Kanmon Strait, eastbound Master/Chief mate/QM:
- no 2/o on bridge: no standby eng.
- 0444: 090° 15.7 knots, proceeding Mihara-Seto strait; sighted opp. on port bow 11° distant 1.55 miles
- 0445: sighted opp. on port bow 11° distant 1.13 miles; giving lighting and sound signals to warn opp.

- 0446: starboard 10° toward right end of strait; opp. echo on port bow 12°, 1,390m
- 0447: opp. echo on port bow 17°, 880m. no sight of opp. nav. light; blast sound sig. keeping starboard 10° helm
- 0448: opp. on port bow 450m; hard starboard; collision on her port quarter with opp. stem.
- 0449: stop eng. hard port, but no stop of starboard turn.
- 0450: dead slow ahead
- 0451: slow ahead. finding close distance to Oki-no-suzume Island, stop eng. and full astern
- 0452: grounding
