Analysis of fires and firefighting operations on fully cellular container vessels over the period 2000 – 2015

Diploma dissertation

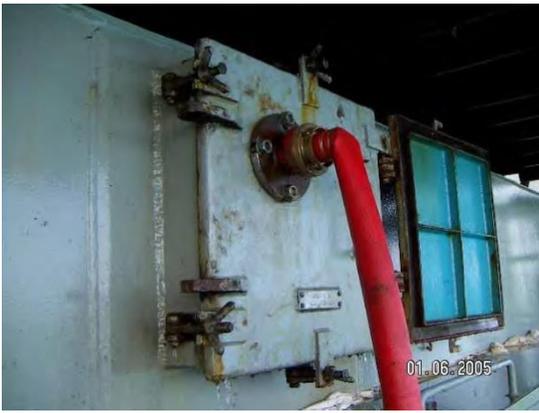
Figure 24, Modified ventilation flap on the CMS PUNJAB SENATOR
 Source: (Bundesstelle für Seeunfalluntersuchung, 2006, p. 9 Reederei Laeisz)

- Hoses can be laid out on deck to cool the vessel's structure and the pontoon hatch cover by pumping water over a large area (shown in green in Figures 25 and 26).
- A makeshift sprinkler system can be made by opening the ventilation grilles on the *upper deck* or by cutting through the ventilation flaps with cutting equipment to pump water into the hold (shown in magenta and blue in Figures 25 and 26). This would require a considerable amount of time working in the danger zone. The bilge pump of the hold would have to be able to pump out the quantity of water introduced in order to avoid free surface effects.

A comparable incident occurred in 2005 on the German container vessel CMS PUNJAB SENATOR. In this case, nobody entered the hold in order to localize the fire. Instead, a visual inspection was carried out through the hold access hatch. The measures taken by the crew were restricted to the introduction of CO₂, the introduction of water through a modified ventilation flap and cooling of the *upper deck* and the pontoon cover (cf. Bundesstelle für Seeunfalluntersuchung, 2006, pp. 8-10).
