## Position paper of the International Union of Marine Insurance (IUMI)

### Fires on ro-ro passenger vehicle decks

7 February 2017

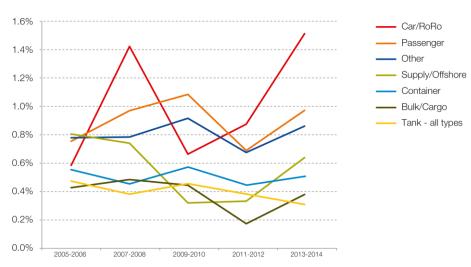
#### *Fire/Explosion claims frequency by vessel type*<sup>4</sup>*:*

Marine underwriters have witnessed that the frequency of fires in the car/ro-ro passenger vessel segment is increasing and is currently at a level twice the frequency of fires on most other vessel types. While cargo on other vessels categories are specifically loaded and packaged for carriage by sea, cargo that is rolled off and on a vessel represents a significant roadside fire risk. Although the risk of fire is substantially lower when a car/lorry is in transit than in operation, the high number of negligible risks could add up to a significant risk. More than one per cent of vessels in the car/ro-ro passenger vessel segment experiences a fire every year<sup>3</sup>. Compared with other causes, fires are often more severe when they occur, resulting in tragic loss of life and costly damage to vessels. Cargo fires are the most frequent type in this segment.

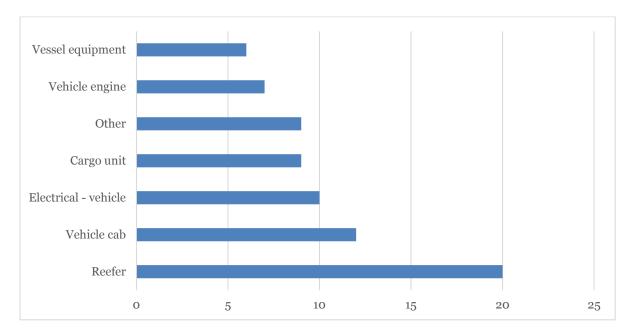
*Fires on ro-ro vehicle decks* 1994-2011<sup>6</sup>:

Analysis of available casualty data and maritime accident reports in recent years have identified several sources of fires within ro-ro vehicle decks<sup>5</sup>. A significant number of these incidents have occurred because of electrical fires. The single most frequent source of fires are reefer units, powered by either electrical cable or a dedicated diesel unit. Electrical equipment on board, vehicle cabs and vehicle engines have also been identified as the source in several of these casualties.

Casualty data clearly indicates that a very high percentage of ro-ro fires emanate from the vehicles themselves, specifically from trailer reefer units, cab fires and electrical and engine fires, rather from the cargo itself. IUMI strongly recommends that regulators, shippers and operators address the way vehicles presented for carriage can be made safe, thus effectively improving the inherent risk of carrying vehicles on ro-ro tonnage, specifically lorries.
