Main firefighting system on tourist vessel "ineffective" says report

By Insurance Marine News, 30th January 2018

An investigation by New Zealand's Transport Accident Investigation Commission into the fire on and subsequent sinking of tourist vessel PeeJay V has found that the main firefighting system was ineffective and that staff did not fully understand how it should work.

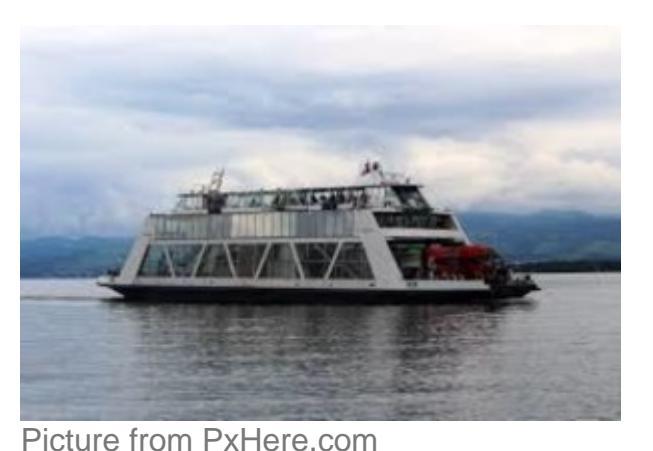
PeeJay V burnt to the waterline and sank. One crew member suffered smoke inhalation, but noone else was seriously injured.

The Commission said that the CO2 fire suppression system was ineffective because oxygenated air was able to enter the engine room through several openings, including a cable duct that could not be closed. The Commission added that the placement of the life-saving apparel and equipment on board was appropriate, and the fact that it could not all be accessed served to highlight the difficulty faced by operators of smaller vessels when choosing where to put such equipment.

Maritime New Zealand has agreed to review the maritime rules about fire alarms and remote extinguishers in vessels of this type with enclosed engine spaces.

It will also encourage people who design, install and use CO2 fixed fire-fighting systems to fully document and understand how these systems work.
